Watercare Services Limited

QUEEN STREET WASTEWATER DIVERSION PROGRAMME: MAYORAL DRIVE ALIGNMENT PROJECT

PRELIMINARY AND DETAILED SITE INVESTIGATION

24 JUNE 2025

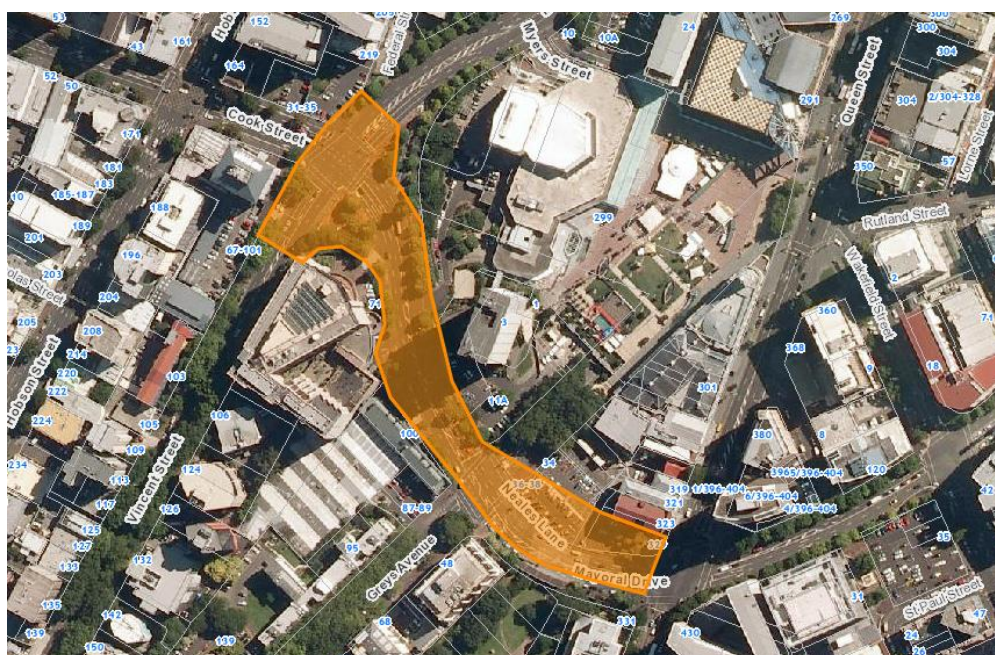
Figure 2-1: Mayoral Drive Alignment project area in orange

The project is located within Auckland City Centre, on a section of Mayoral Drive between Queen Street and Vincent Street/Cook Street, along with a short extension within Vincent Street (see Figure 2-1 for approximate project area). In addition, the project works will also occur within a surface carpark at 34-38 Greys Avenue and 329 Queen Street. The CSA site will contain both a section of the proposed wastewater pipeline and the CSA for the Queen Street programme¹.

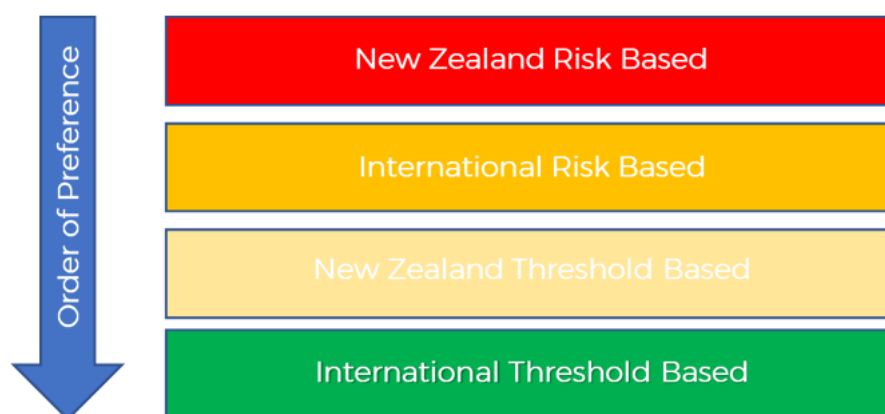
Figure 6.1: Hierarchy of guideline values

This section summarises the reference source for guideline values that we have adopted for the current project and future use of the Site. The selected guideline values have been based on the MfE *Contaminated Land Management Guidelines No. 2: Hierarchy and Application in New Zealand of Environmental Guideline Values (Revised 2011)* (CLMG No. 2) (MfE, 2011) below:

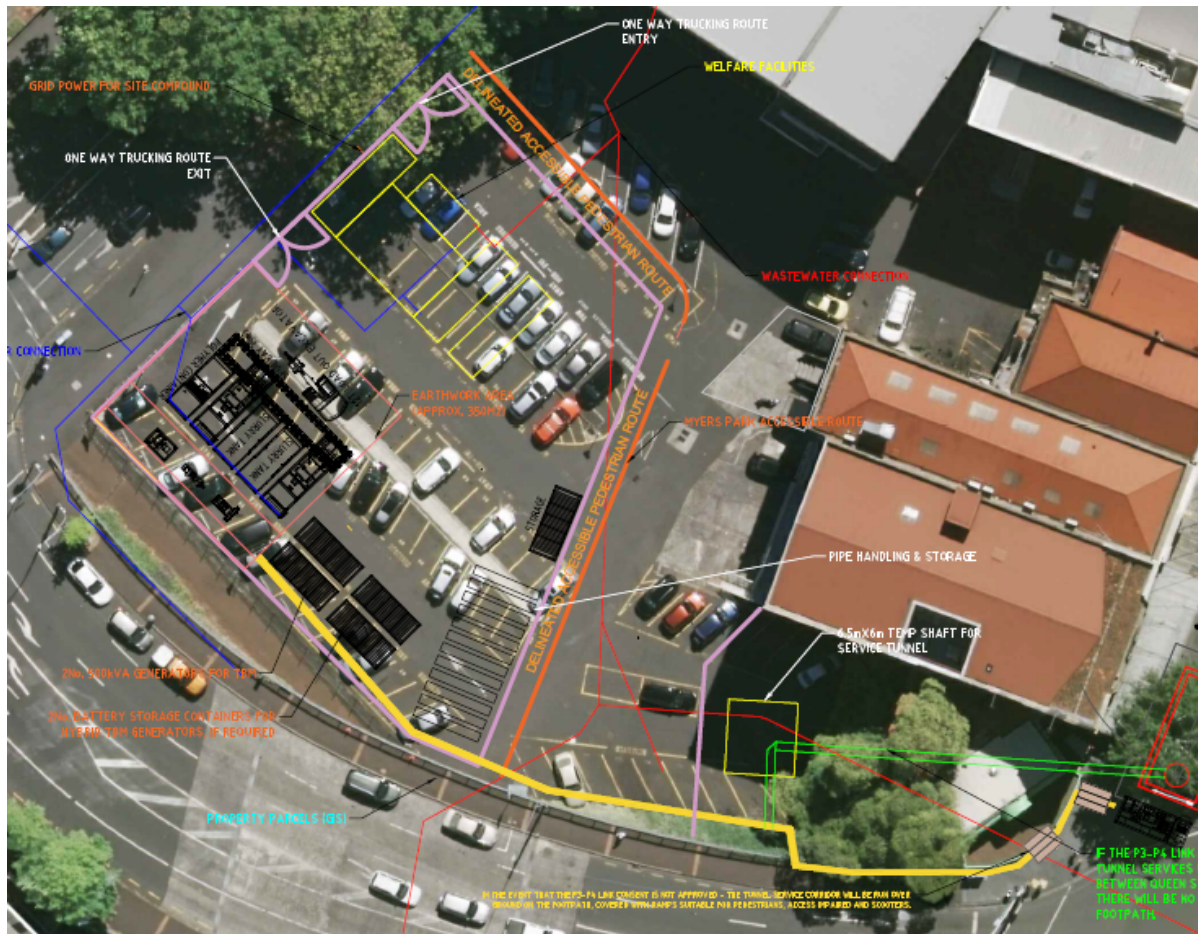
Figure 2: Layout for Construction Support Area

A construction support area (CSA) will be located within the Greys Avenue Carpark and will utilise the space previously established during the Part 3 (package A) works. Some office/cabin reconfiguration may be required (refer Figure 2 below).
