GUIDANCE NOTES - EXAMPLE PLANS

When applying for WORKS OVER (NETWORKS)

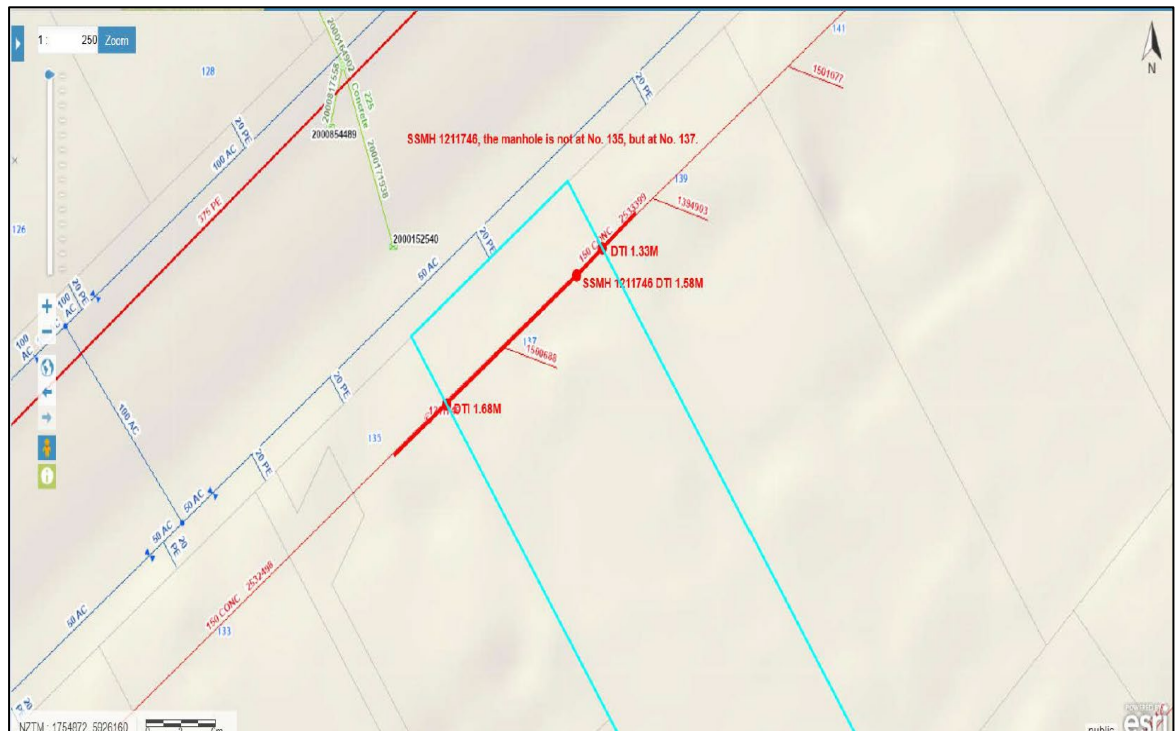
SAMPLE CCTV AS-BUILT PLAN

- Snip of GIS / Site plan showing the upstream manhole and downstream manhole GIS ID and property entry DTI and exit DTI (DTI- Depth to Invert)

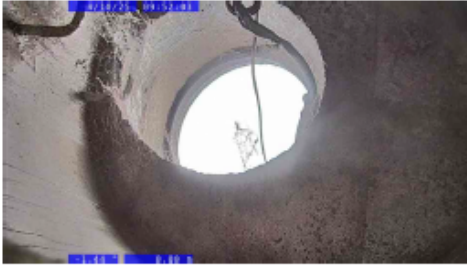
<p>SSM 1211746--1290583_0001.jpg, 00:00:10, 0.00m Inspection start, node reference: SSMH 1211746</p> </div> <div>

1:130	m +	OC	Observation	MPEG	Photo Grade				
SSMH 1211746									
0.00	IS		Inspection start, node reference: SSMH 1211746	00:00:10 SSM 1211746--1290583_0

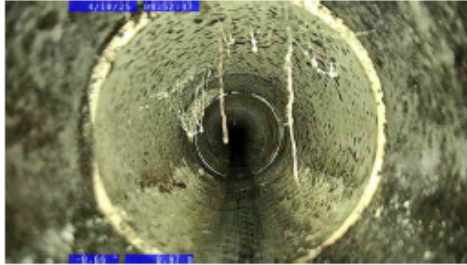
<p>SSM 1211746--1290583_0002.jpg, 00:00:35, 0.97m Material change / CONCRETE TO PVC</p> </div> <div>

0.97	MC		Material change / CONCRETE TO PVC	00:00:35 SSM 1211746--1290583_0					
1.73	LO		Lateral exists OK, at 11 o'clock	00:01:00 SSM 1211746--1290583_0

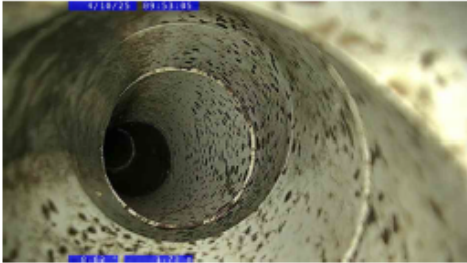
<p>SSM 1211746--1290583_0003.jpg, 00:01:00, 1.73m Lateral exists OK, at 11 o'clock</p> </div> <div>

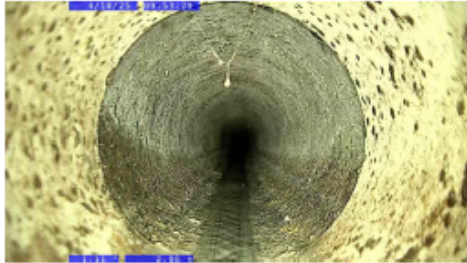
<p>SSM 1211746--1290583_0004.jpg, 00:01:13, 2.08m Material change / PVC TO CONCRETE</p> </div> <div>

2.08	MC		Material change / PVC TO CONCRETE	00:01:13 SSM 1211746--1290583_0					
9.11	LB		Lateral blank. There is visible evidence that the lateral is blank, at 10 o'clock	00:03:06 SSM 1211746--1290583_0

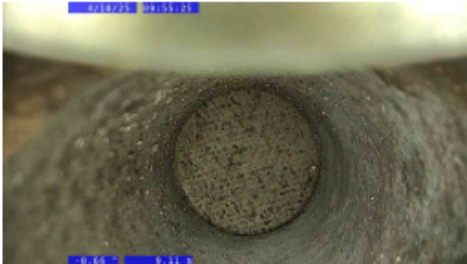
<p>SSM 1211746--1290583_0005.jpg, 00:03:06, 9.11m Lateral blank. There is visible evidence that the lateral is blank, at 10 o'clock</p> </div> <div>

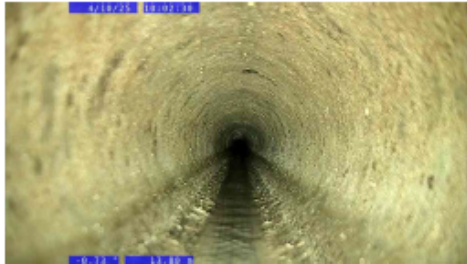
<p>SSM 1211746--1290583_0006.jpg, 00:04:37, 13.80m General comment / EXIT BOUNDARY,DTI,1.68m</p> </div>

13.80	GC		General comment / EXIT BOUNDARY,DTI,1.68m	00:04:37 SSM 1211746--1290583_0					
18.06	IA		Inspection abandoned / EXIT BOUNDARY,4M	00:05:37 SSM 1211746--1290583_0					
STR No. Def	STR Peak	STR Mean	STR Total	STR Grade	SER No. Def	SER Peak	SER Mean	SER Total	SER Grade
0	0.0	0.0	0.0	1.0	0	0.0	0.0	0.0	1.0
137 MOORE STREET HILLCREST 04-10-25									
Page 1
